HAMPDEN COUNTY
WESTFIELD, MASSACHUSETTS

STEVENS PAPER COMPANY (UPPER) DAM
MA-00075

NATIONAL DAM INSPECTION PROGRAM
CORPS OF ENGINEERS

As a result of a site visit conducted on June 18, 1979, the Stevens Paper Co. (Upper) Dam - MA 00075 has been found to have a "low" hazard potential. This brief letter report documenting the determination of a "low" hazard potential classification of the dam is submitted in lieu of a complete Phase I Investigation Report.

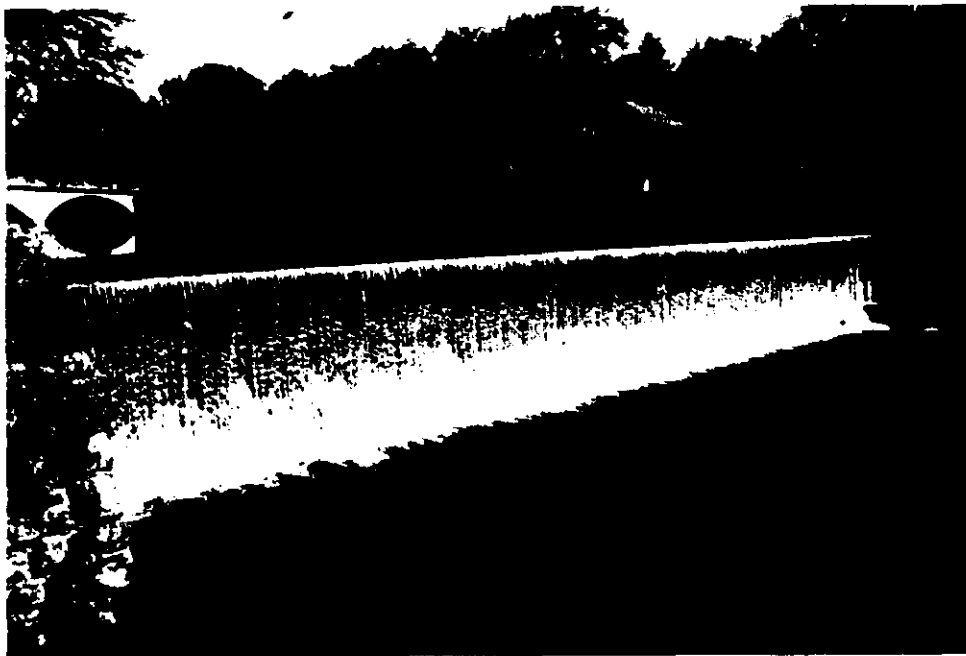
1. Overview of dam from downstream right abutment. Portion of Hortons Bridge located upstream of dam is shown in background.

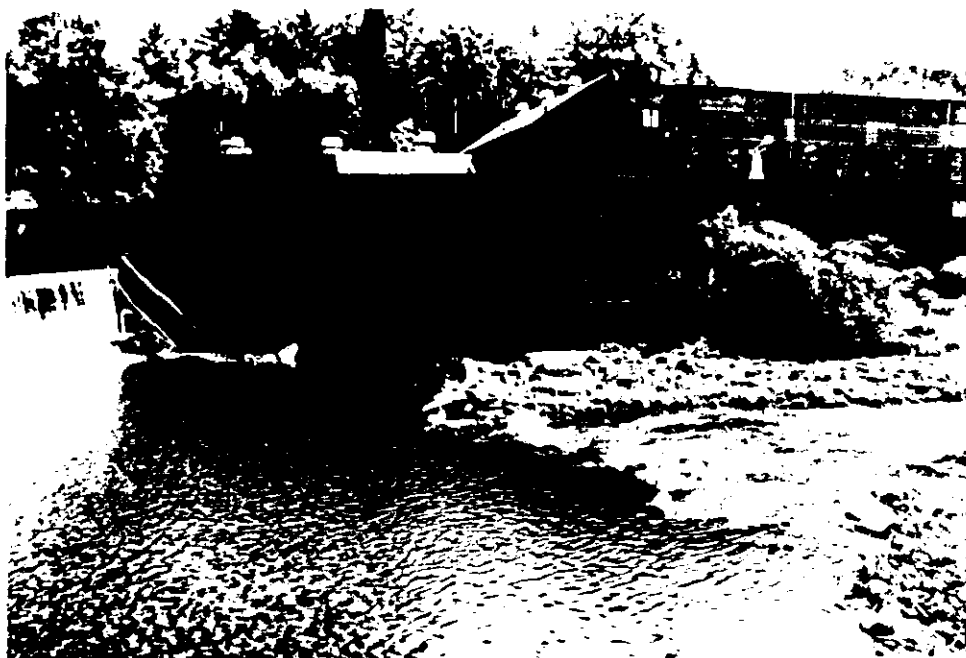
2. View of mill on downstream left bank.

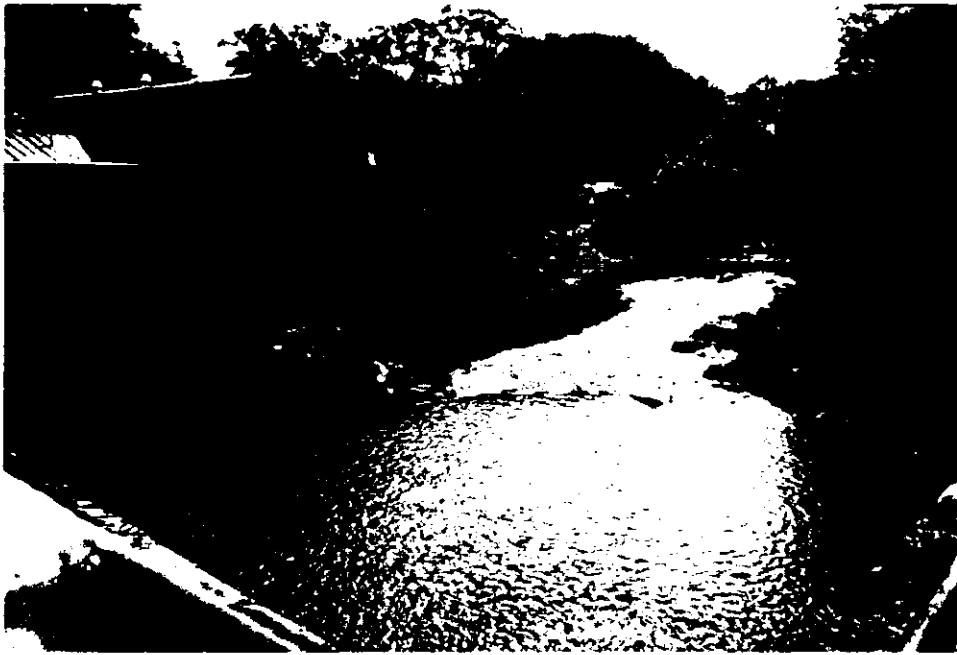
3. Downstream channel from right abutment.

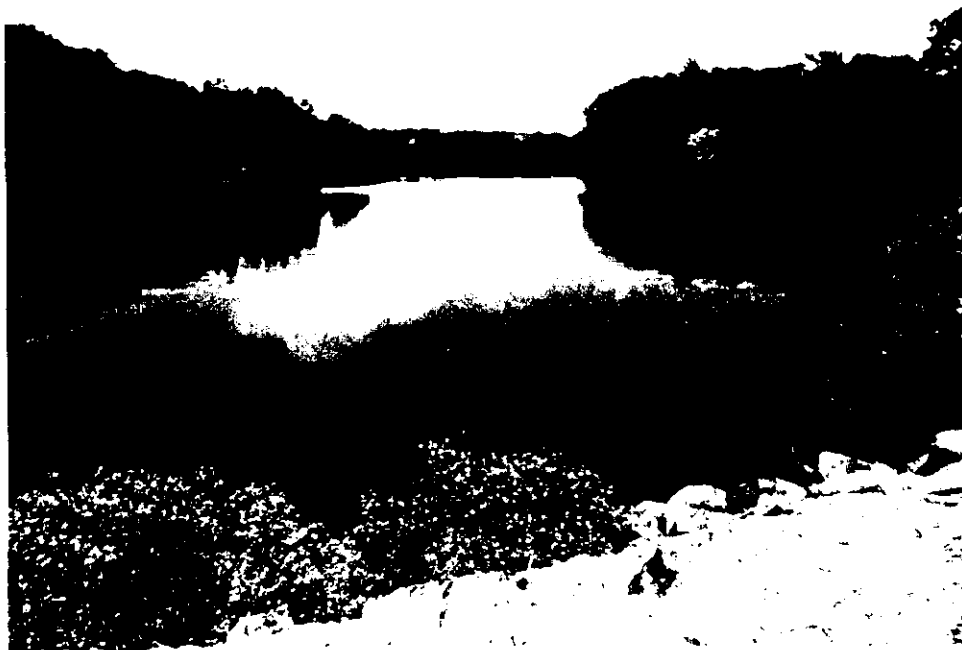
7. View of Crane Pond from Lower Stevens Dam left abutment.

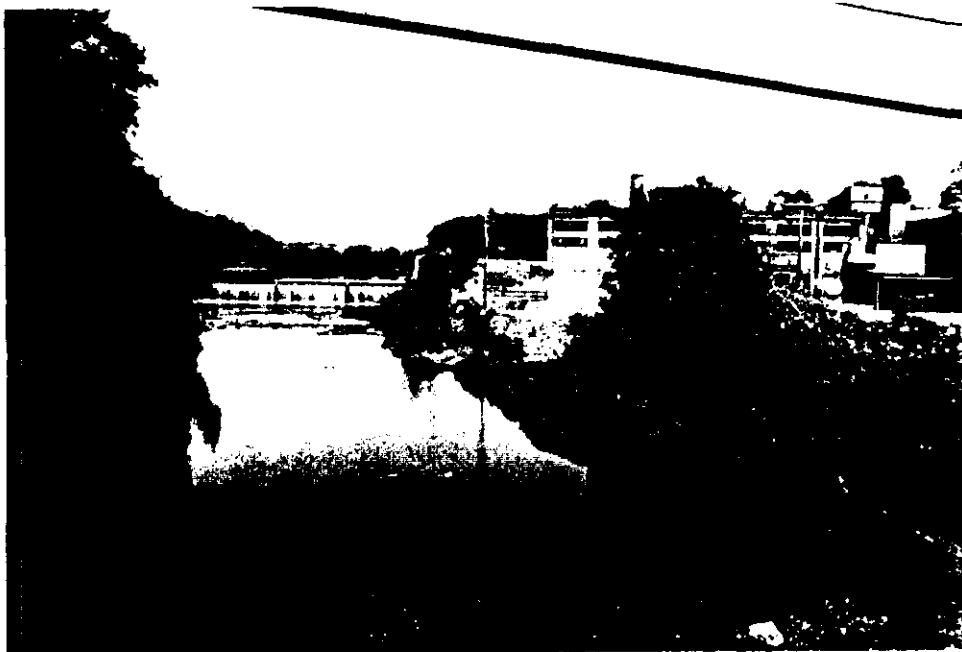
8. View of Lower Stevens Dam and adjacent mill from Southwick Road Bridge.

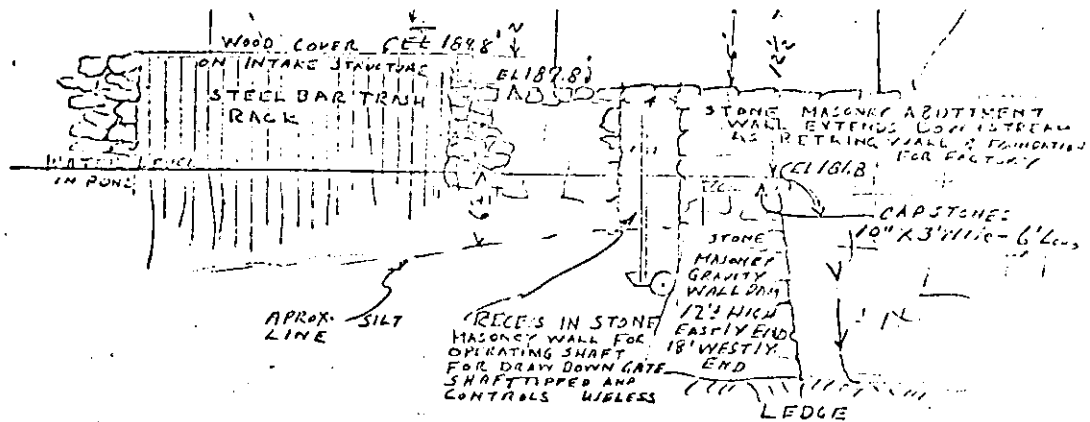
X SECTION AA - SHOWING EAST ABUTMENT & INTAKE FOR MILL

According to the Mill Maintenance Supervisor the control at the penstock inlet has not been operated for some time but control valves and gates inside the Mill are operating. The penstock entry chamber is covered with a plank deck with the hand wheel controlling the intake gate projecting above it. Close inspection of the intake was not practical. There is a steel bar trash rack on the river side of the entry chamber.

In 1957 a concrete flood training wall was built on top of the old stone abutment wall on the northeasterly end of the dam with a leg extending into the slope to present flooding of the Mill and Mill Yard. At this time the shaft for the remote control for the drawdown gate in a recess in the abutment wall was forced outward making it inoperative. The concrete wall and stone masonry abutment are in good condition.

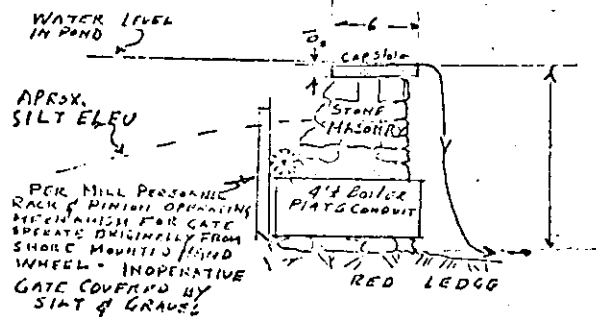
X SECTION BB - THRU 4" DRAW DOWN CONDUIT - 10'± FROM EAST END DAM

Clogged or Blocked Spillway Drawdown gate inoperative and covered with silt, sand and gravel by floods.

The old four foot diameter drawdown conduit through the base of the stone masonry spillway wall about ten feet from the east end was visible on the downstream face. Silt and other debris covered the upstream end and the gate. The Plant Maintenance Supervisor said that the gate was originally operated by a rack and pinion arrangement located under the water at the gate. The pinion was turned by means of a hand wheel located on the abutment through a system of gears. This drawdown has not been opened for years and the operating mechanism is inoperative.

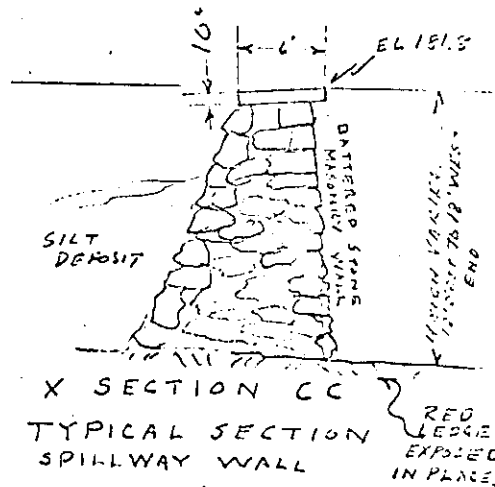
X SECTION CC
TYPICAL SECTION
SPILLWAY WALL

8. DAM DOWNSTREAM FACE: Slope 1 in 6 Batter - 8" to foot. ^{Cut stone on crest overhangs}
Material: Turf . Brush & Trees . Rock Fill . ^{Stone} Masonry X. Wood .
Other .
Condition: 1. Good X. 3. Major Repairs .
2. Minor Repairs . 4. Urgent Repairs .
Comments: Unable to inspect spillway wall and toe due to 4 to 6 inches of water flowing
over wall. Wall apparently founded on red ledge. Noted three small boils
100' downstream.

The alignment and grade of spillway structure and the abutments were true with no visible sags or bulges and no loose or missing stones noted. It appears to be built on red sand stone ledge.
